VenaTech[®] Convertible[™] Vena Cava Filter System

CLINICAL STUDY SUMMARY

(Pages 11-17 of Instructions for Use)

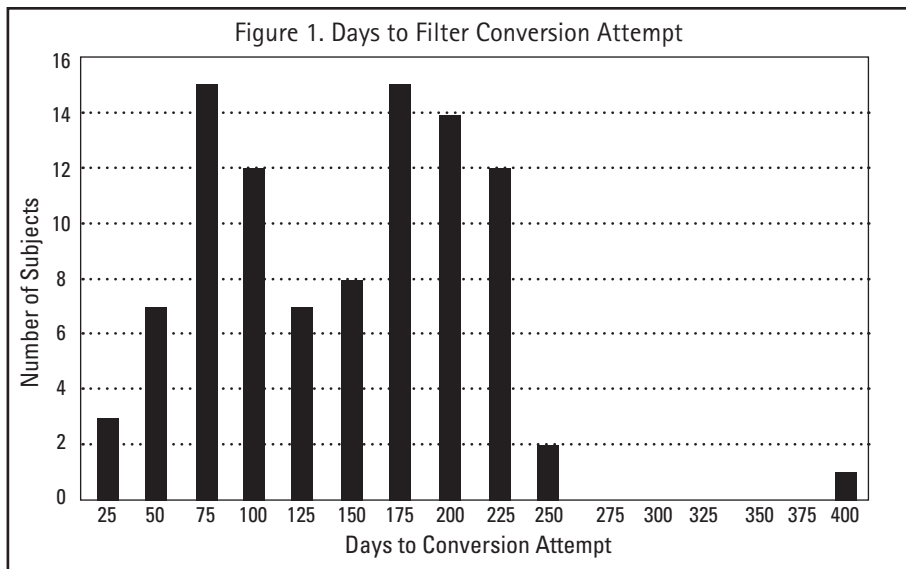
The mean days to filter conversion was 130.7 days (range 15 to 391 days). The average reported conversion procedure time was 30.7 minutes (the conversion procedure duration was defined as the time the introducer is placed to the time all ancillary accessories were removed). In 82.3% of conversion procedures, accessory tools were used to assist including guiding catheters, guidewires and angioplasty balloons (as allowed per the instructions for use). Figure 1 presents days to conversion attempt.
